RANCHO CAMULOS

CULTURAL LANDSCAPE ACTIVITIES FOCUS AREA PLAN EVALUATIONS

RANCHO CAMULOS NATIONAL HISTORIC LANDMARK VENTURA COUNTY, CALIFORNIA

Focus Area Plant Evaluation Report

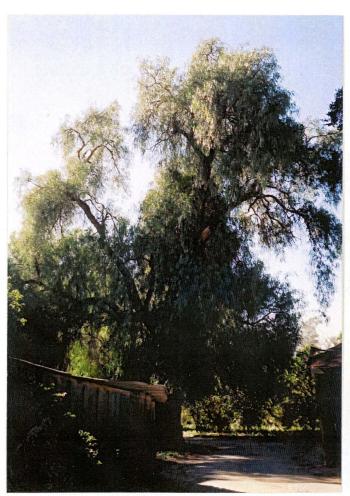
Although the three (3) Schinus molle (California Pepper) numbered 1, 2 and 3 appear relatively healthy all three trees exhibit significant defects. Tree number one has trunk and branch cavities and dieback. Tree number two is a regrowth from a decayed trunk. Tree number three has a major trunk cavity with active decay and exhibits a weak branch structure.

The three (3) California Pepper would be considered undesirable specimens in a highly utilized public landscape. Tree number 1 and 3 have a high potential for failure based on the evident trunk cavities and decay. Tree number 2 is basically a regrowth from a failed and decayed tree stump and should be removed.

1A – Schinus molle No. 1

I would recommend removal of all three (3) California Pepper specimens.

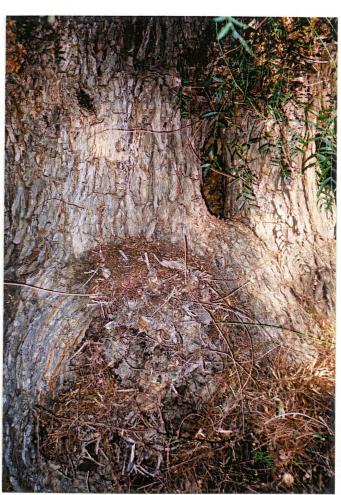
1B – Basal Cavity No. 1

In order to preserve trees numbered 1 and 3, the trees would require considerable pruning to reduce branch and foliage density including significant crown reduction. All of the materials, debris and soil covering the base of the trunks require removal.

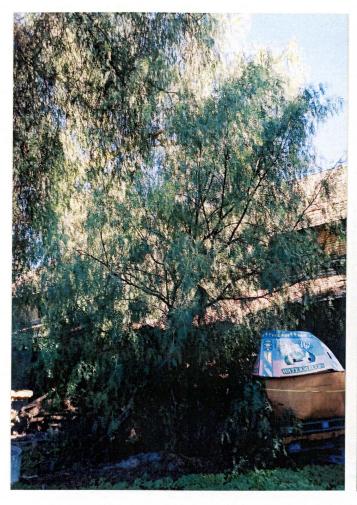
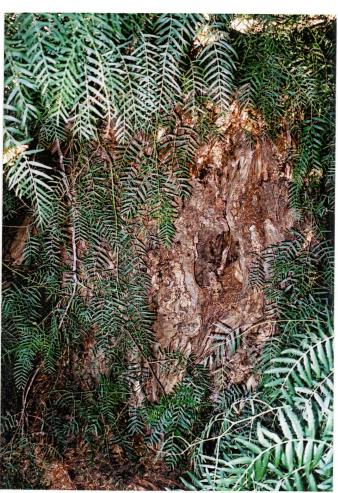
2A – Schinus molle No. 2 2B - Decayed trunk No. 2

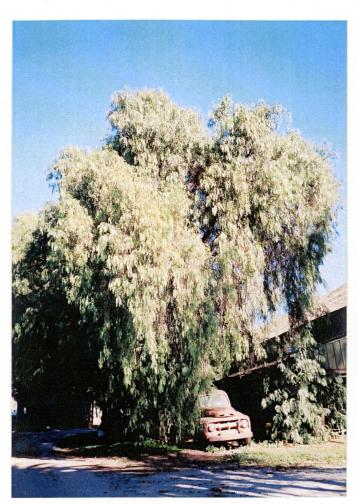
3A – Schinus molle No. 3

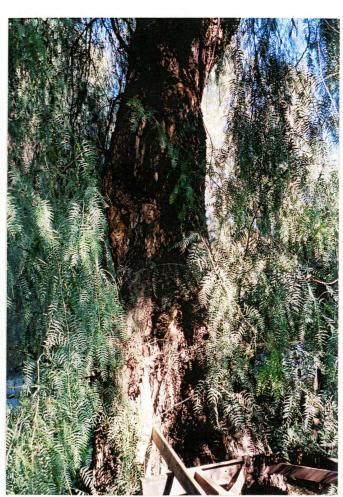
3B - Trunk cavity No. 3

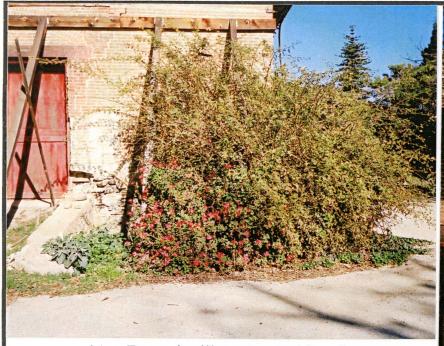
The Rose species, Bougainvillea and Poinsettia adjacent to the winery appear as relatively new plantings with no site historical significance (No. 4-8 & 10-11). Removal of these plants would not affect the cultural or heritage aspects of preservation planning. It also should be noted that the Eugenia shrubs (No. 24 & 27), Hollywood Juniper (23), Oleander, Eugenia hedge and Ficus (31) surrounding the Nachito vel Valley Adobe (Visitor Center) are either in poor condition or represent plantings since the 1920's historical period. Only the Eugenia hedge and large Eugenia shrub mass Number 24 merit consideration for preservation.

Climbing the east wall of the Winery is a unique epiphytic cactus, *Hylocereus undatus* (Number 9). Based on the size of this specimen, it appears that this was one of the original ranch plantings. It is indigenous to tropical forest regions of Mexico and Central and South America where natives commonly call it 'Pitaya'. In Asia, it is called the 'Dragon Fruit'. The cactus produces a nocturnal blooming white flower followed with a 4" red oval fruit that is edible and considered to have good flavor and sweetness. The fruit is consumed fresh and has been developed into a commercial crop in many regions of the world.

4A – Bougainvillea

4C - Cactus >

The Pitahaya cactus is worthy of preservation as part of the original heritage site. Depending on the proposed renovation of the Winery, this plant may require removal but is easily propagated for replanting.

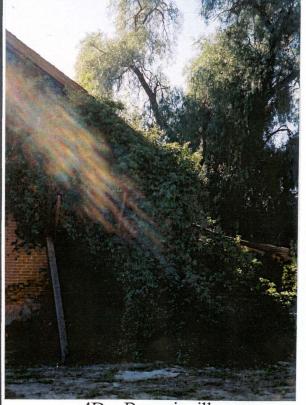
4D – Bougainvillea

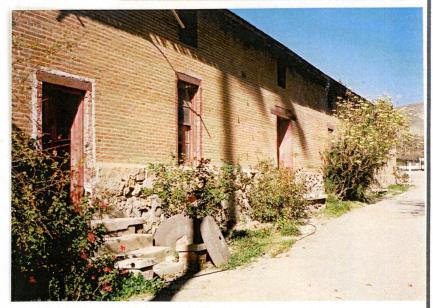
4B – Roses & Poinsettia

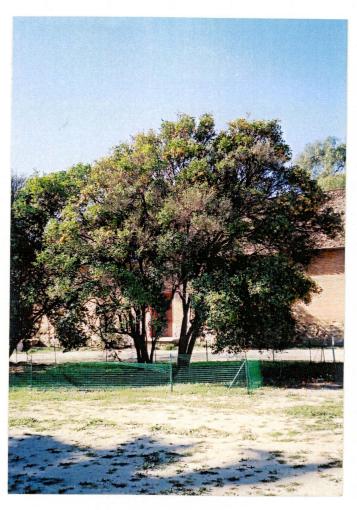
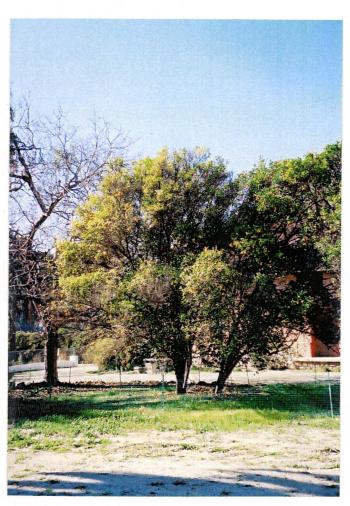
The citrus orchard (No. 22) contains a mixed assembly of various evergreen fruit types. Trees numbered 12 – 17 are groupings of Calamondin (Sour-Acid Mandarin). These are exhibited in photographs 5A-B. There is one Avocado in the orchard. The remaining trees are orange and grapefruit. Most of the trees appear fairly mature with some new plantings present. Overall, the trees evidence lack of maintenance. Dieback, deadwood and nutrient deficiencies are common throughout the orchard. Photographic exhibits 8A-B and 9A-B illustrate the orchard tree conditions.

5A – Calamondin Citrus No. 12, 13, 14 5B – Calamondin Citrus No. 15, 16, 17

In order to preserve the orchard, the weed growth needs to be controlled. The seedling palm and volunteer California Pepper trees require removal. All of the trees are in need of a nutrient fertilization program. Pruning is required throughout to remove the deadwood and shape the trees. The orchard would benefit from installation of a permanent irrigation system. It would be further recommended that the entire orchard ground area be covered with a 4-6" layer of mulch.

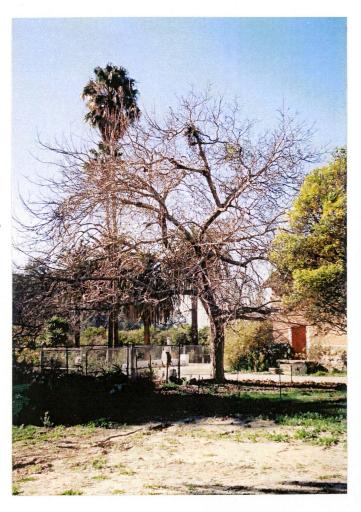
Tree Number 18 is a fairly young Black Walnut located east of the winery. This tree is in overall good condition with only winter dormant pruning required. A portion of the root zone is covered with an asphalt driveway. Removal of the asphalt within the canopy drip line and addition of mulch would be of benefit to this specimen.

6A – Juglans nigra No. 18

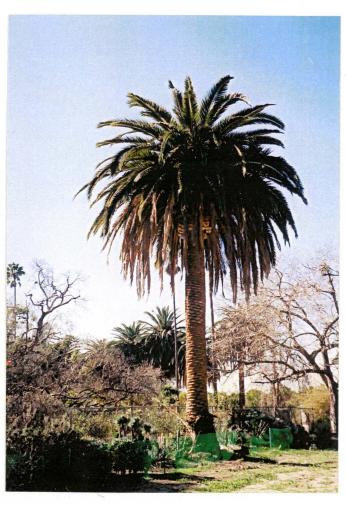
The Canary Island Date Palm (No. 19) is located on the south perimeter of the study zone. The trunk measures 29" with a height and spread of 45' x 25'. This tree is fairly immature, most likely not more than 20- 25 years old. The palm is in good health and would only require lower dead frond removal for preservation. Should this tree not be acceptable where located, it can be easily transplanted to another location.

6B – Phoenix canariensis No. 19

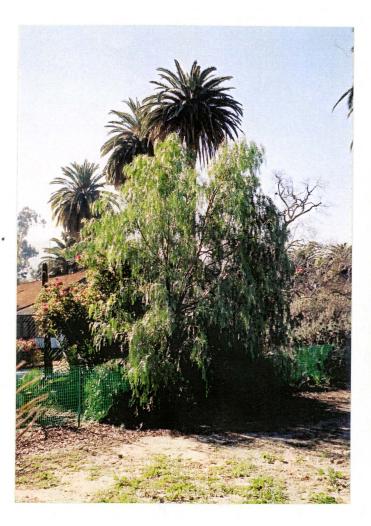
Tree Number 20 is a small young seedling *Schinus molle* (California Pepper) located on the south property boundary near the Canary Island Date Palm. The tree is in good condition. This specimen did not exist as part of the original historical development of the property.

7A – Schinus molle No. 20

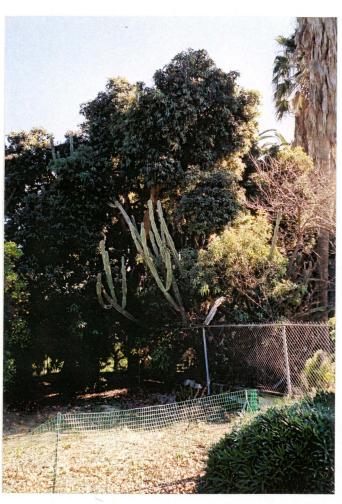
Although tree Number 21 is located outside of the study area, a portion of the canopy extends into the southeast corner of the study site. This is a large multi-trunk Red Iron Bark Eucalyptus. The overall tree health is good. The tree would benefit from pruning to shape the canopy and remove deadwood. In addition, the soil and debris covering the base of the trunk should be removed to expose the original root crown flare. There are several large cactus plants that are growing up through the Eucalyptus canopy. These cactus should be transplanted to a more desirable location.

7B – Eucalyptus sideroxylon No. 21

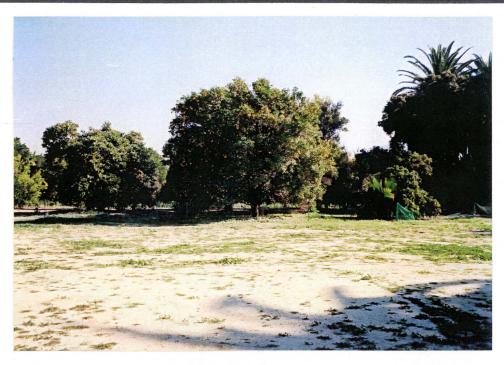
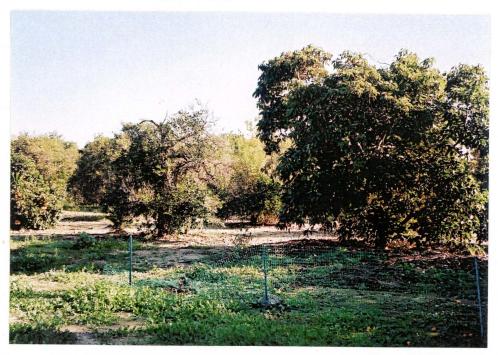
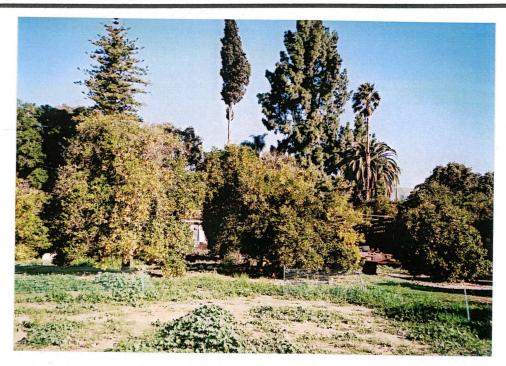
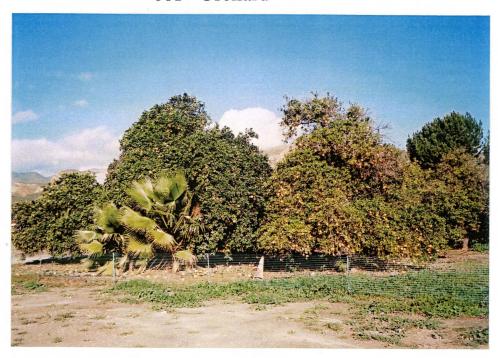
8A - Orchard

8B - Orchard

9A - Orchard

9B - Orchard

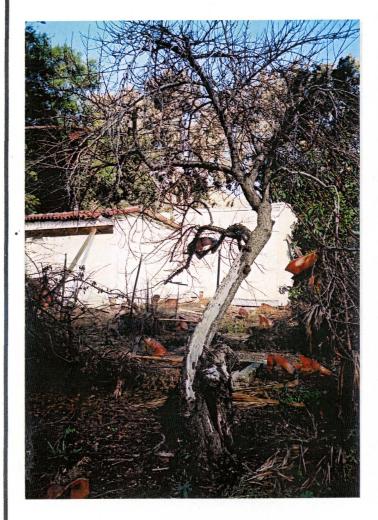
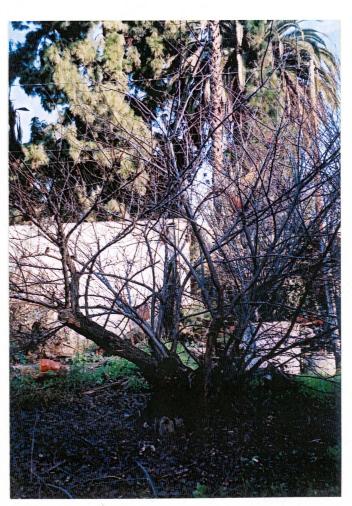
Three (3) of the deciduous fruit trees at the north end of the orchard and the Italian Cypress (No. 23) are recommended for removal due to declining health and poor form. These trees are beyond remediation for potential development into long term desirable specimens.

10A – Deciduous Fruit Tree

10B – Deciduous Fruit Tree

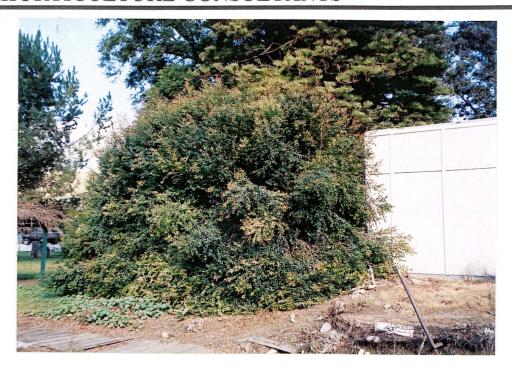
12A - Eugenia Shrub No. 24

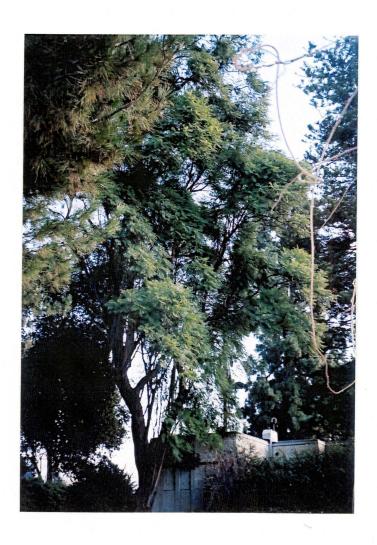
Tree Number 26 is a Jacaranda specimen located just north of the Norfolk Island Pine. The foliage canopy spreads 48' extending into the Norfolk Island Pine and over the Adobe. A small myrtle bush adjacent to the tree trunk should be removed. The soil and debris covering the base of the trunk requires removal to expose the root flare and original grade. The tree would benefit from removing the trunk sucker growth and deadwood with pruning to shape the overall canopy.

Jacaranda No. 26

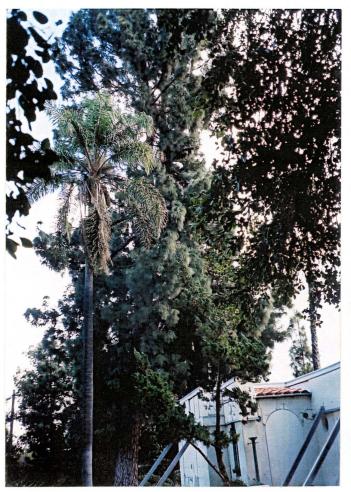
Tree Number 29 is a Queen Palm. The trunk diameter is 15" with a height and spread of 55' x 20'. The west side lacks foliage. The trunk evidences spike marks from previous climbing spurs. This tree is worthy of preservation where located. However, the tree can also be easily transplanted. No mitigations are required.

15A- Queen Palm No. 29 (Canary Island Pine No. 30 in background)

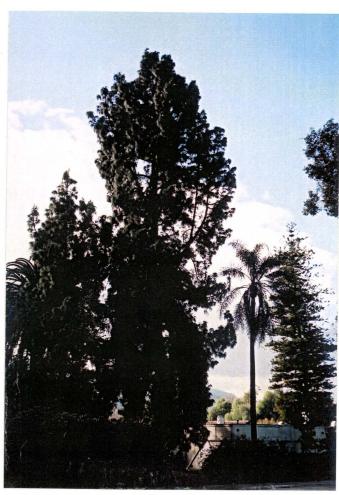
The largest tree in the study area is a 42" trunk diameter Canary Island Pine located to the northeast side of the Adobe. This is evaluated as tree number 30. The height and canopy spread are 90' x 40'. The tree leans slightly to the east, but appears to be stable. Minor deadwood and twig dieback were observed. This tree requires no mitigations at this time.

15B - Canary Island Pine No. 30 (Queen Palm No. 29 on Right, Araucaria No. 25 in background)
