**RANCHO CAMULOS**  
**CULTURAL LANDSCAPE ACTIVITIES**  
**FOCUS AREA PLAN EVALUATIONS**

**RANCHO CAMULOS**  
**NATIONAL HISTORIC LANDMARK**  
**VENTURA COUNTY, CALIFORNIA**

**January 2005**

## **Focus Area Plant Evaluation Report**

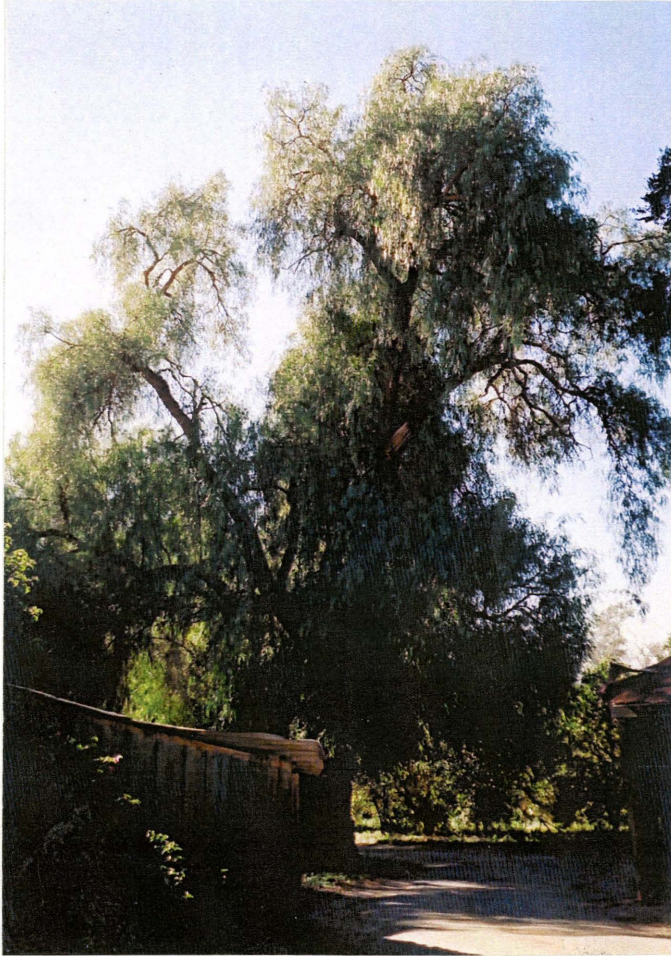
Although the three (3) *Schinus molle* (California Pepper) numbered 1, 2 and 3 appear relatively healthy all three trees exhibit significant defects. Tree number one has trunk and branch cavities and dieback. Tree number two is a regrowth from a decayed trunk. Tree number three has a major trunk cavity with active decay and exhibits a weak branch structure.

The three (3) California Pepper would be considered undesirable specimens in a highly utilized public landscape. Tree number 1 and 3 have a high potential for failure based on the evident trunk cavities and decay. Tree number 2 is basically a regrowth from a failed and decayed tree stump and should be removed.

1A – Schinus molle No. 1

In order to preserve trees numbered 1 and 3, the trees would require considerable pruning to reduce branch and foliage density including significant crown reduction. All of the materials, debris and soil covering the base of the trunks require removal.

I would recommend removal of all three (3) California Pepper specimens.

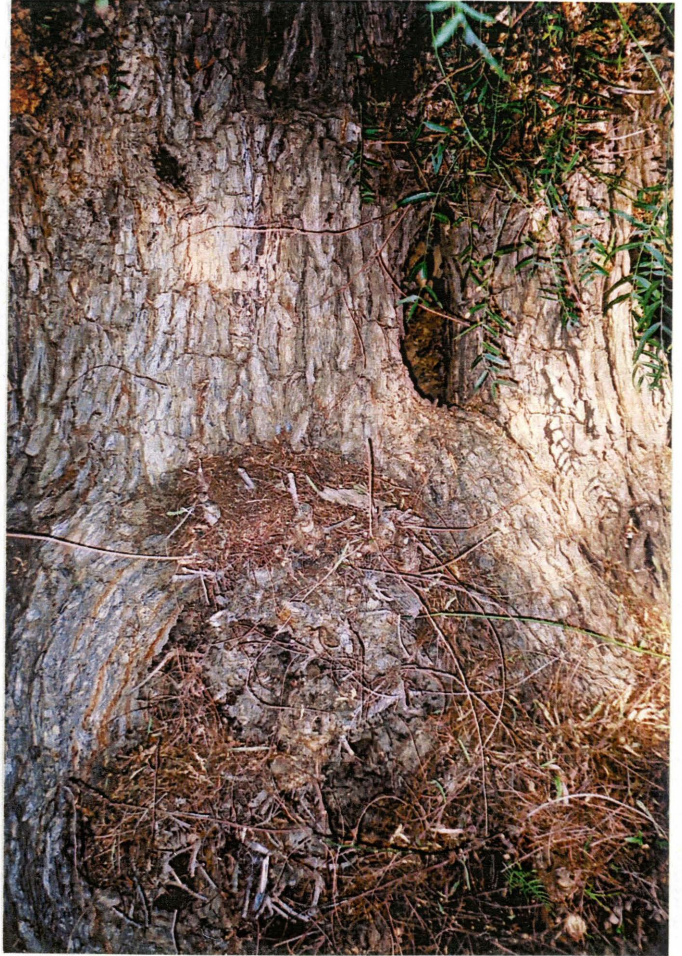
1B – Basal Cavity No. 1

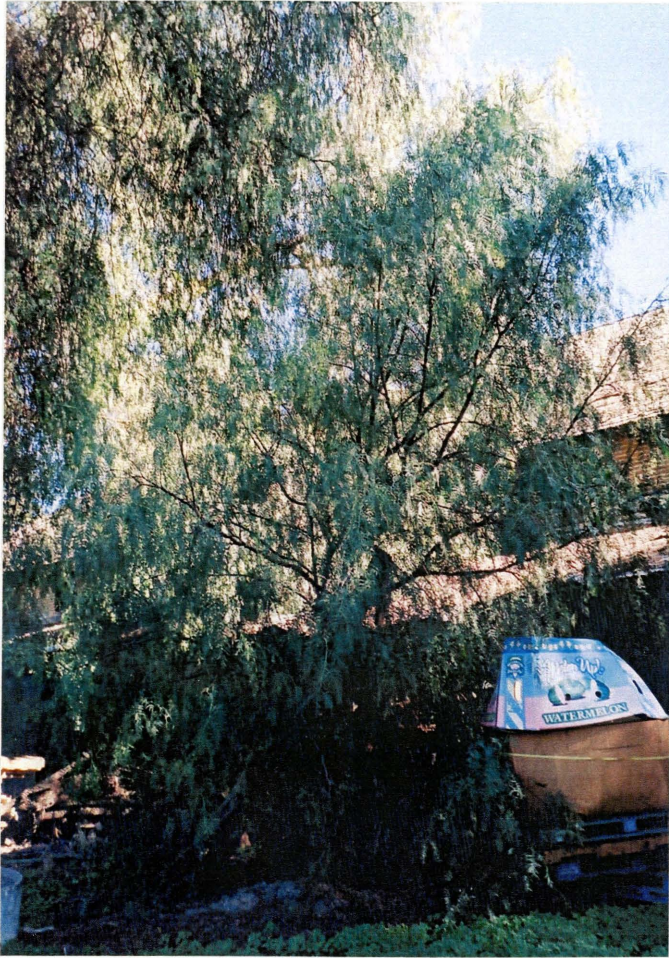
2A – Schinus molle No. 2

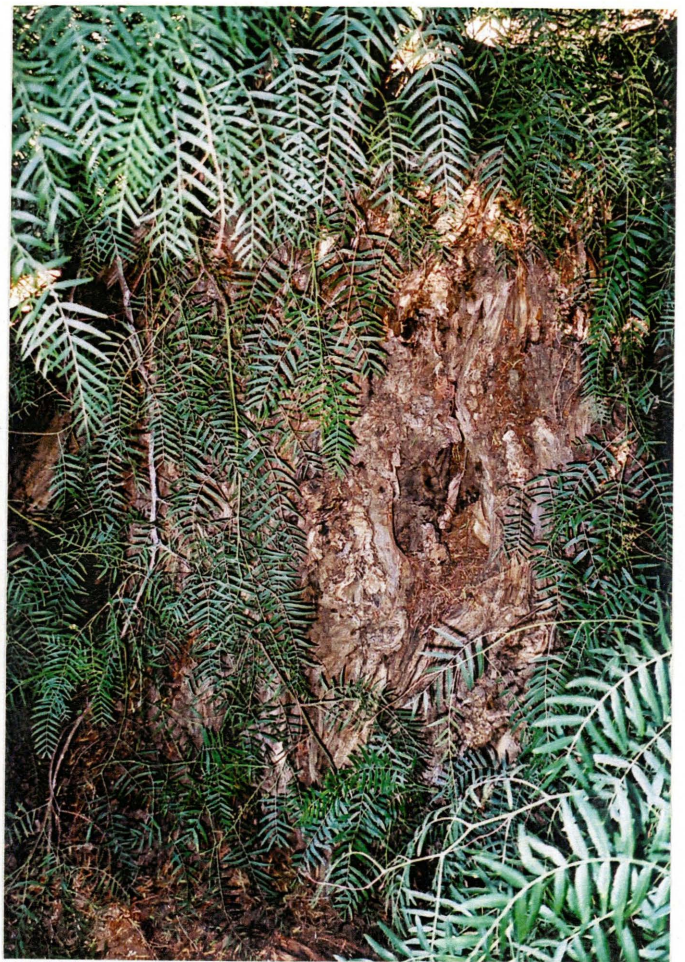
2B - Decayed trunk No. 2

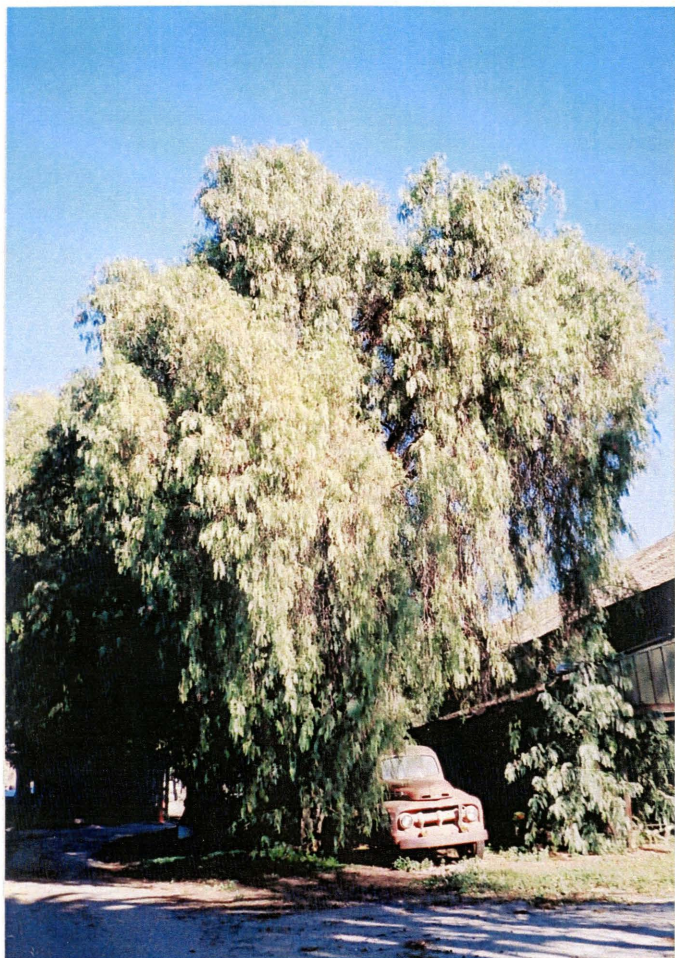
3A – Schinus molle No. 3

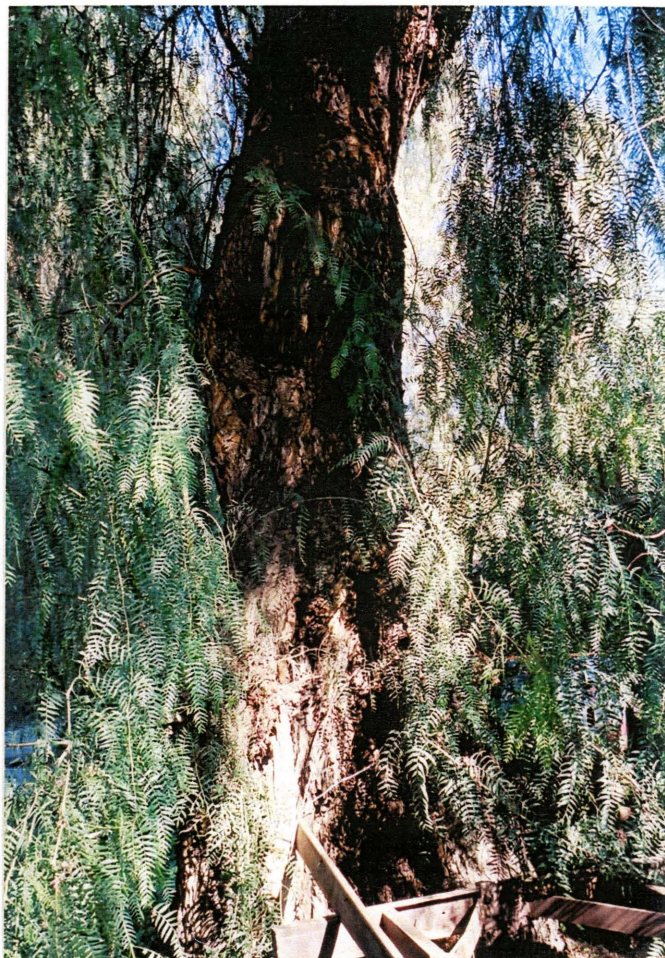
3B – Trunk cavity No. 3

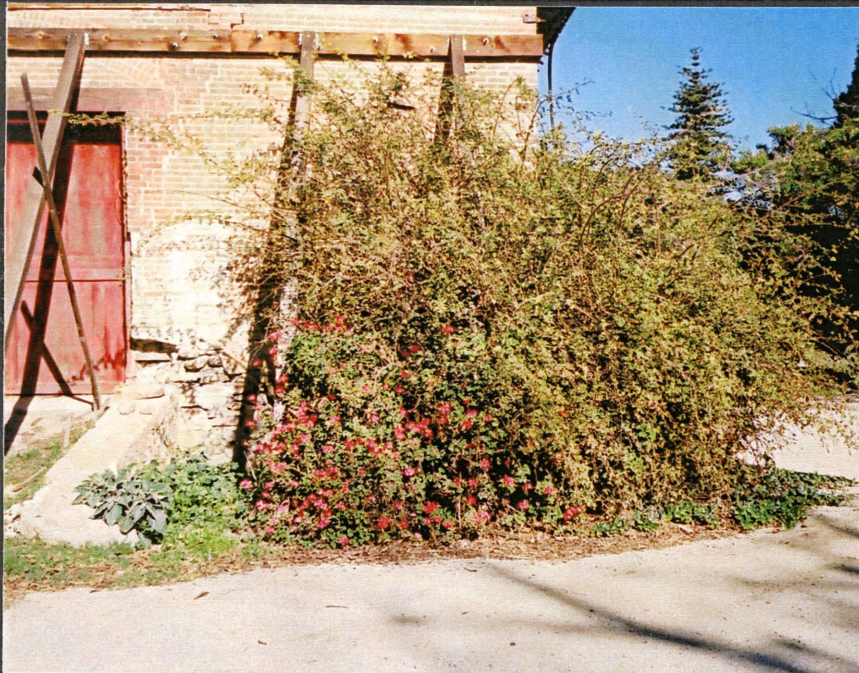
4A – Bougainvillea

The Rose species, Bougainvillea and Poinsettia adjacent to the winery appear as relatively new plantings with no site historical significance (No. 4 -8 & 10 -11). Removal of these plants would not affect the cultural or heritage aspects of preservation planning. It also should be noted that the Eugenia shrubs (No. 24 & 27), Hollywood Juniper (23), Oleander, Eugenia hedge and Ficus (31) surrounding the Nachito vel Valley Adobe (Visitor Center) are either in poor condition or represent plantings since the 1920's historical period. Only the Eugenia hedge and large Eugenia shrub mass Number 24 merit consideration for preservation.

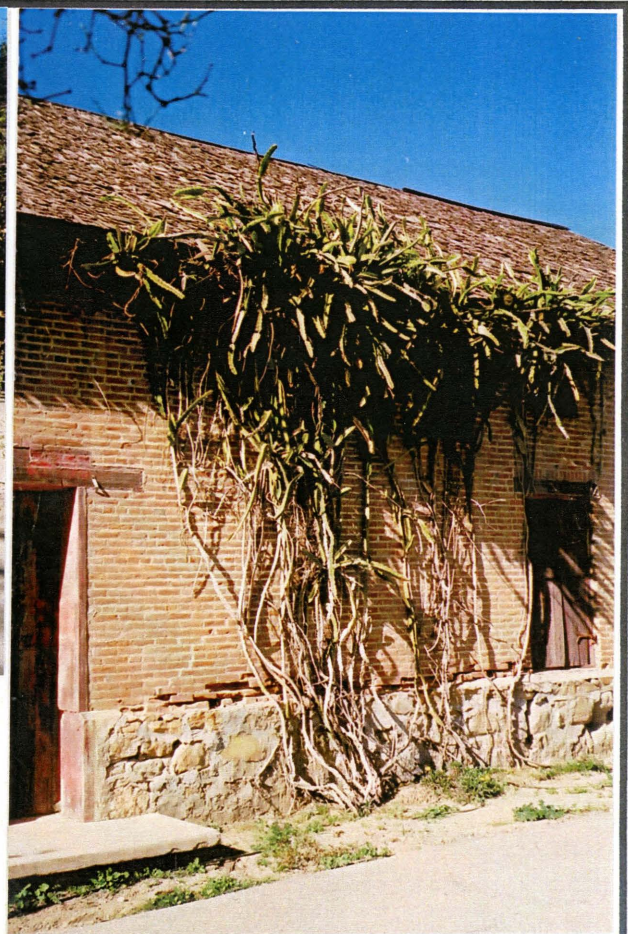
4C – Cactus >

Climbing the east wall of the Winery is a unique epiphytic cactus, *Hylocereus undatus* (Number 9). Based on the size of this specimen, it appears that this was one of the original ranch plantings. It is indigenous to tropical forest regions of Mexico and Central and South America where natives commonly call it 'Pitaya'. In Asia, it is called the 'Dragon Fruit'. The cactus produces a nocturnal blooming white flower followed with a 4" red oval fruit that is edible and considered to have good flavor and sweetness. The fruit is consumed fresh and has been developed into a commercial crop in many regions of the world.

The Pitahaya cactus is worthy of preservation as part of the original heritage site. Depending on the proposed renovation of the Winery, this plant may require removal but is easily propagated for replanting.

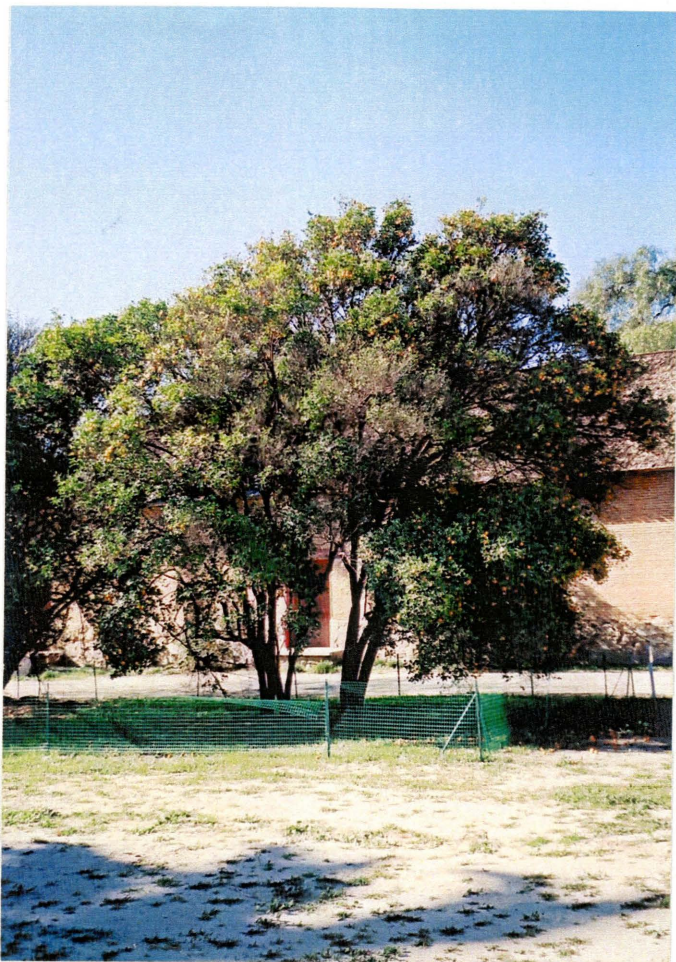
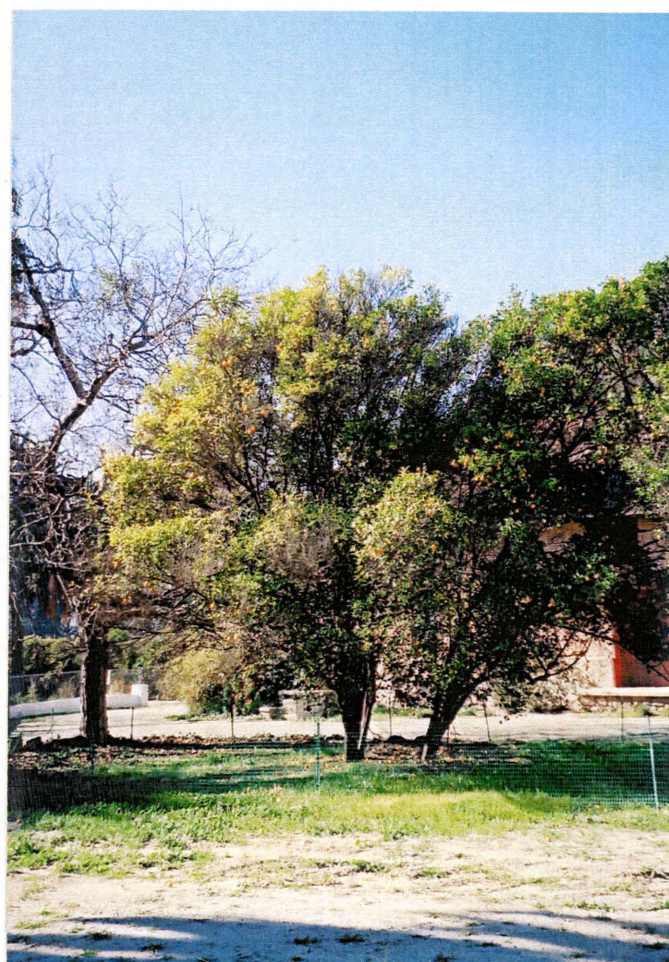
The citrus orchard (No. 22) contains a mixed assembly of various evergreen fruit types. Trees numbered 12 – 17 are groupings of Calamondin (Sour-Acid Mandarin). These are exhibited in photographs 5A-B. There is one Avocado in the orchard. The remaining trees are orange and grapefruit. Most of the trees appear fairly mature with some new plantings present. Overall, the trees evidence lack of maintenance. Dieback, deadwood and nutrient deficiencies are common throughout the orchard. Photographic exhibits 8A-B and 9A-B illustrate the orchard tree conditions.

5A – Calamondin Citrus No. 12, 13, 14

5B – Calamondin Citrus No. 15, 16, 17

In order to preserve the orchard, the weed growth needs to be controlled. The seedling palm and volunteer California Pepper trees require removal. All of the trees are in need of a nutrient fertilization program. Pruning is required throughout to remove the deadwood and shape the trees. The orchard would benefit from installation of a permanent irrigation system. It would be further recommended that the entire orchard ground area be covered with a 4-6" layer of mulch.

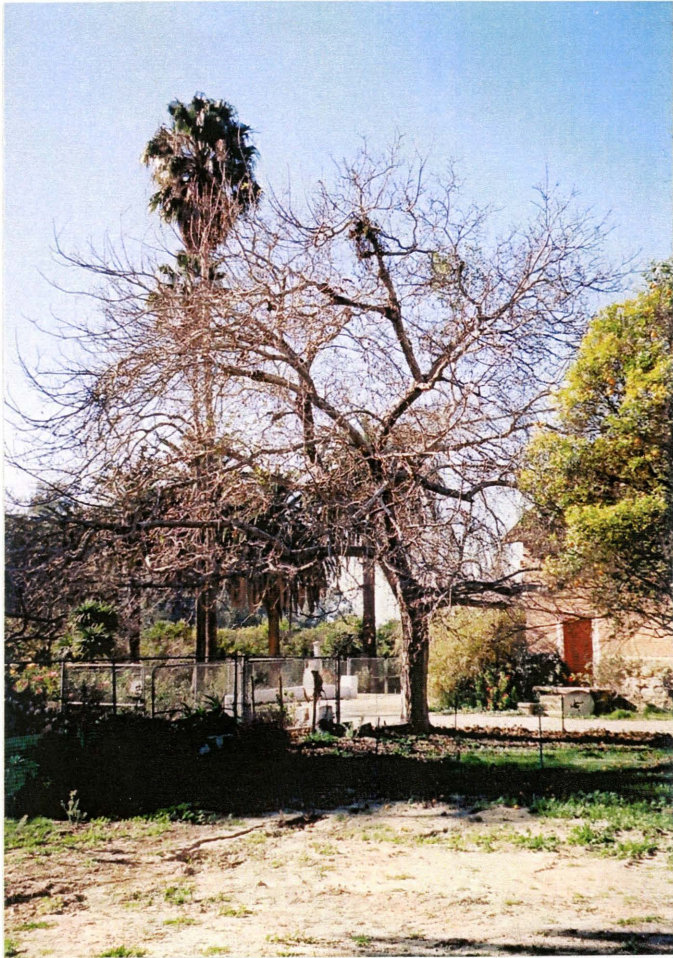
6A – *Juglans nigra* No. 18

Tree Number 18 is a fairly young Black Walnut located east of the winery. This tree is in overall good condition with only winter dormant pruning required. A portion of the root zone is covered with an asphalt driveway. Removal of the asphalt within the canopy drip line and addition of mulch would be of benefit to this specimen.

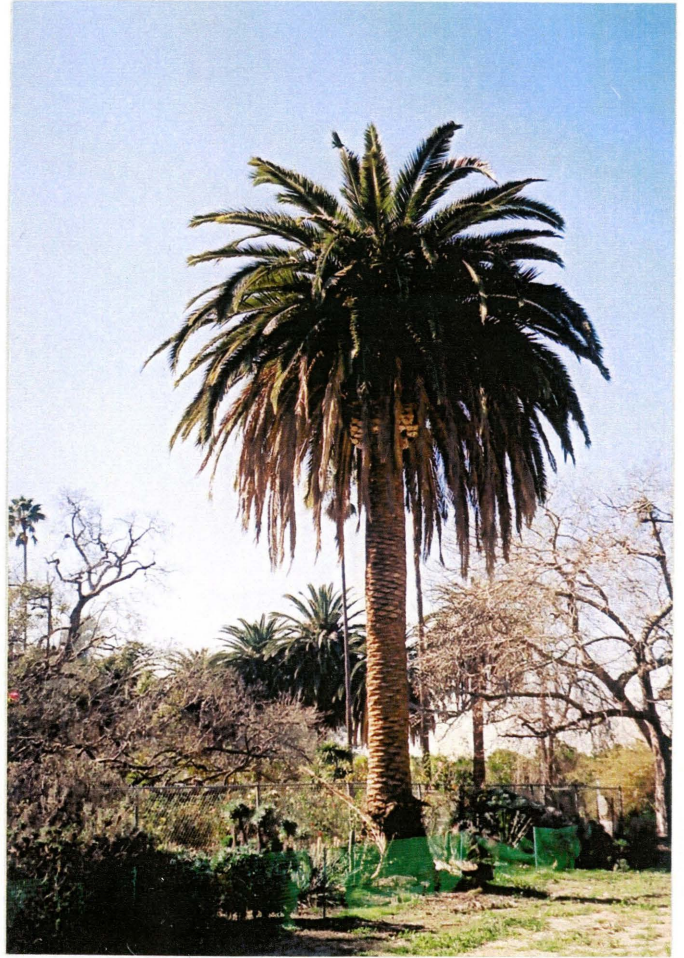
6B – *Phoenix canariensis* No. 19

The Canary Island Date Palm (No. 19) is located on the south perimeter of the study zone. The trunk measures 29" with a height and spread of 45' x 25'. This tree is fairly immature, most likely not more than 20- 25 years old. The palm is in good health and would only require lower dead frond removal for preservation. Should this tree not be acceptable where located, it can be easily transplanted to another location.

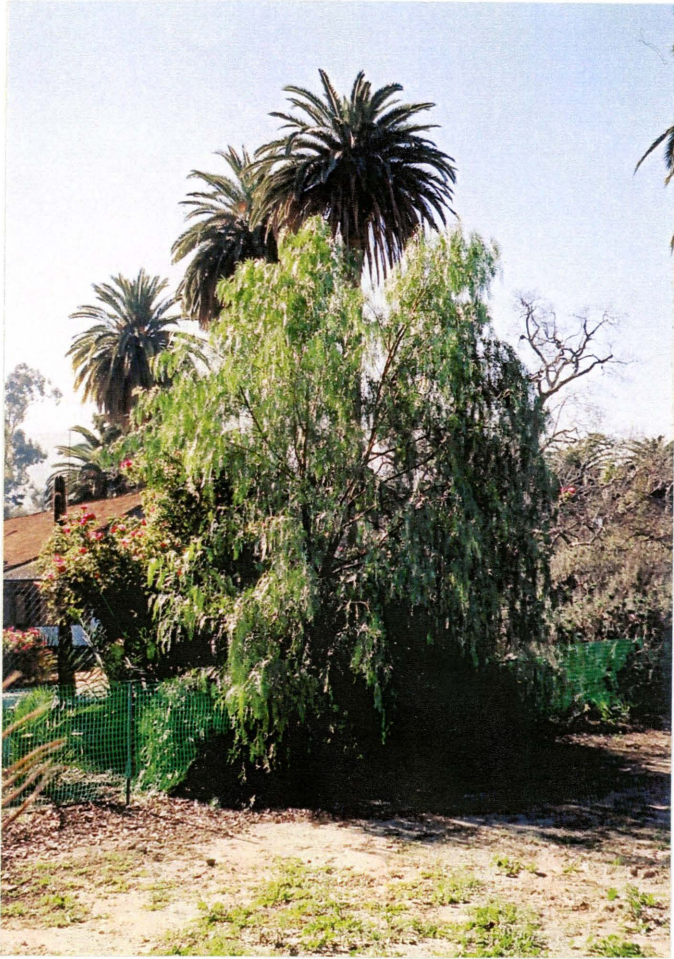
7A – *Schinus molle* No. 20

Tree Number 20 is a small young seedling *Schinus molle* (California Pepper) located on the south property boundary near the Canary Island Date Palm. The tree is in good condition. This specimen did not exist as part of the original historical development of the property.

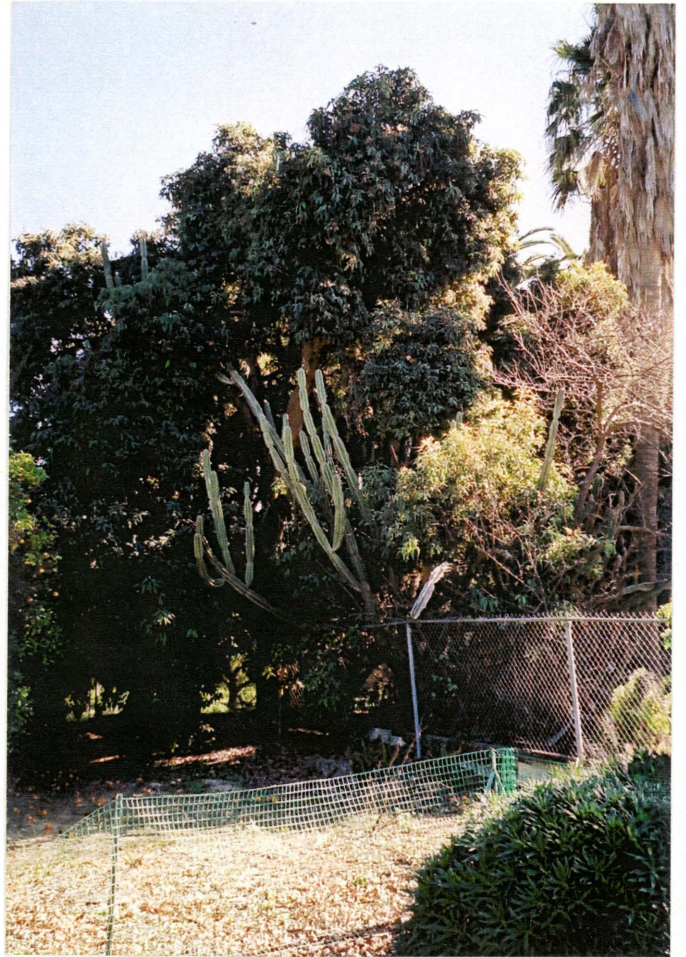
7B – *Eucalyptus sideroxylon* No. 21

Although tree Number 21 is located outside of the study area, a portion of the canopy extends into the southeast corner of the study site. This is a large multi-trunk Red Iron Bark Eucalyptus. The overall tree health is good. The tree would benefit from pruning to shape the canopy and remove deadwood. In addition, the soil and debris covering the base of the trunk should be removed to expose the original root crown flare. There are several large cactus plants that are growing up through the Eucalyptus canopy. These cactus should be transplanted to a more desirable location.

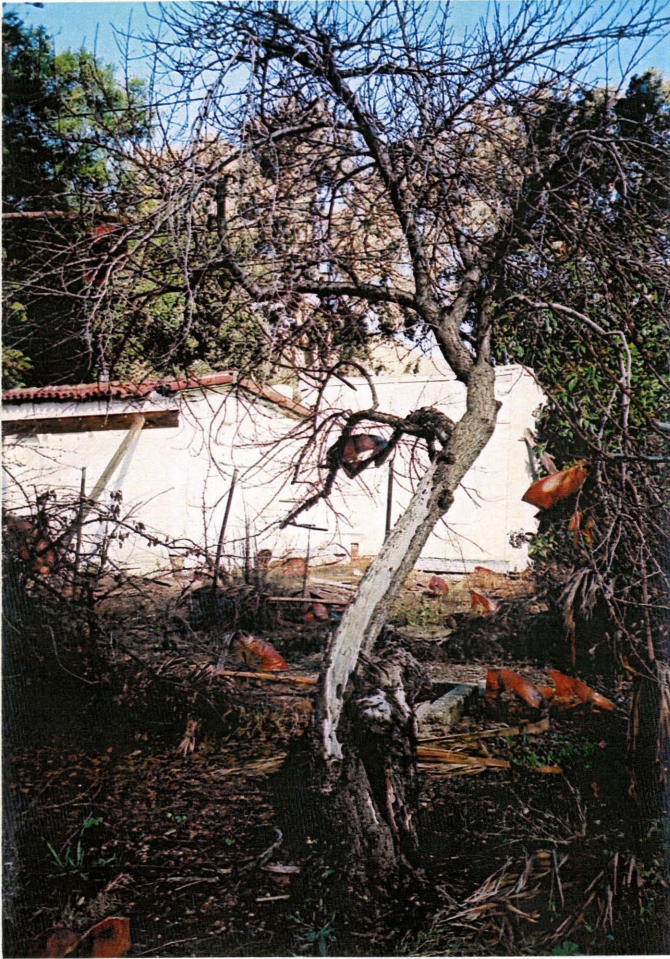
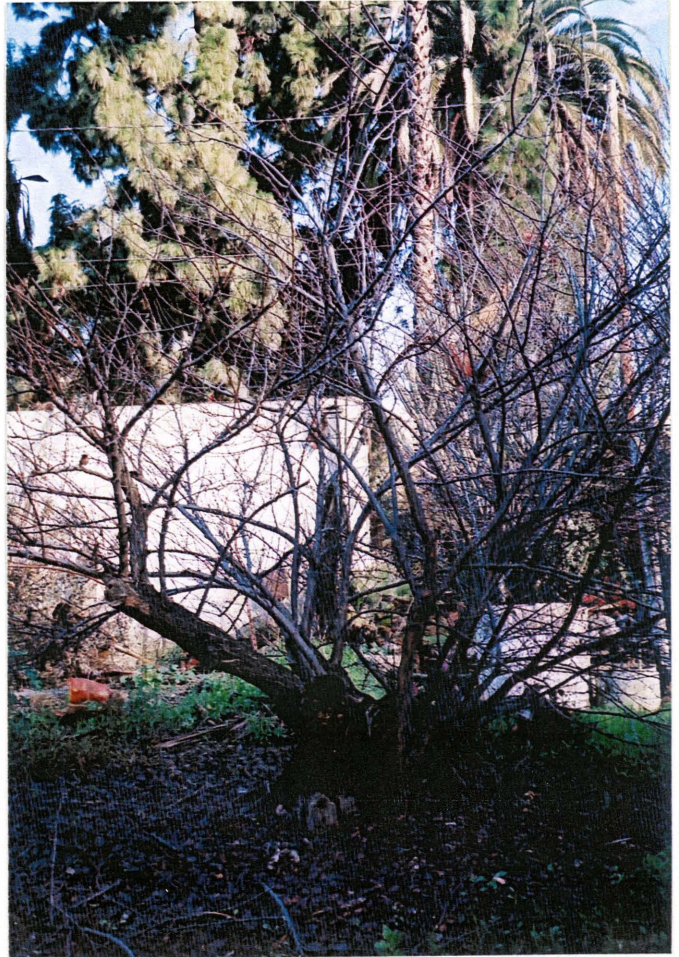
Three (3) of the deciduous fruit trees at the north end of the orchard and the Italian Cypress (No. 23) are recommended for removal due to declining health and poor form. These trees are beyond remediation for potential development into long term desirable specimens.

10A – Deciduous Fruit Tree

10B – Deciduous Fruit Tree

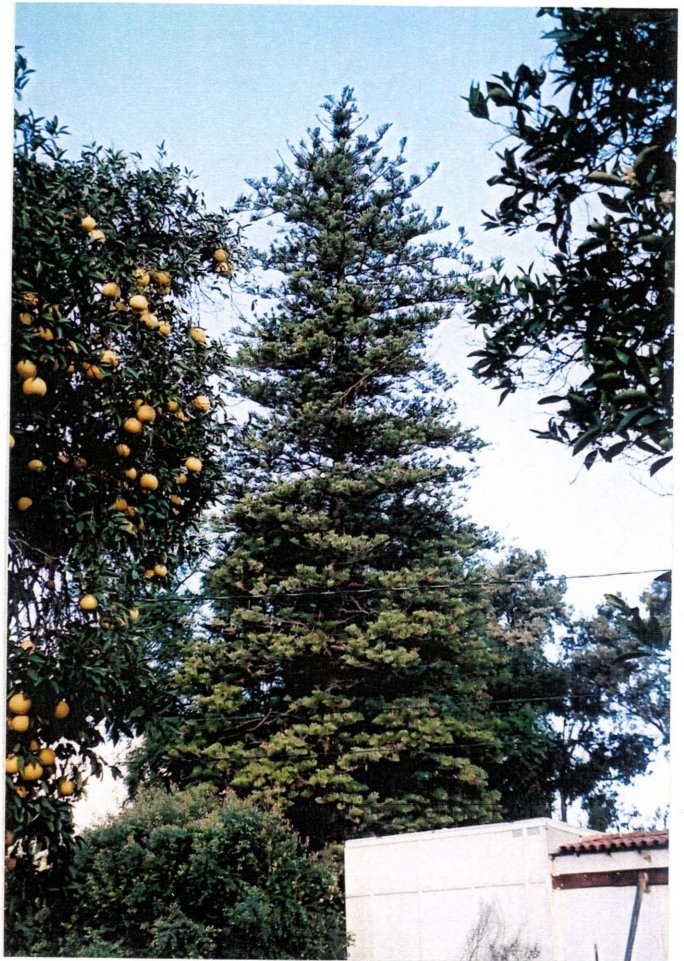
11B – Norfolk Isl. Pine No. 25

Tree Number 25 is a 75' tall *Araucaria heterophylla* (Norfolk Island Pine) located in the west side garden area adjacent to the Adobe. Remnants of an old brick walk surround the tree. The tree is in excellent condition and requires no mitigations for preservation.

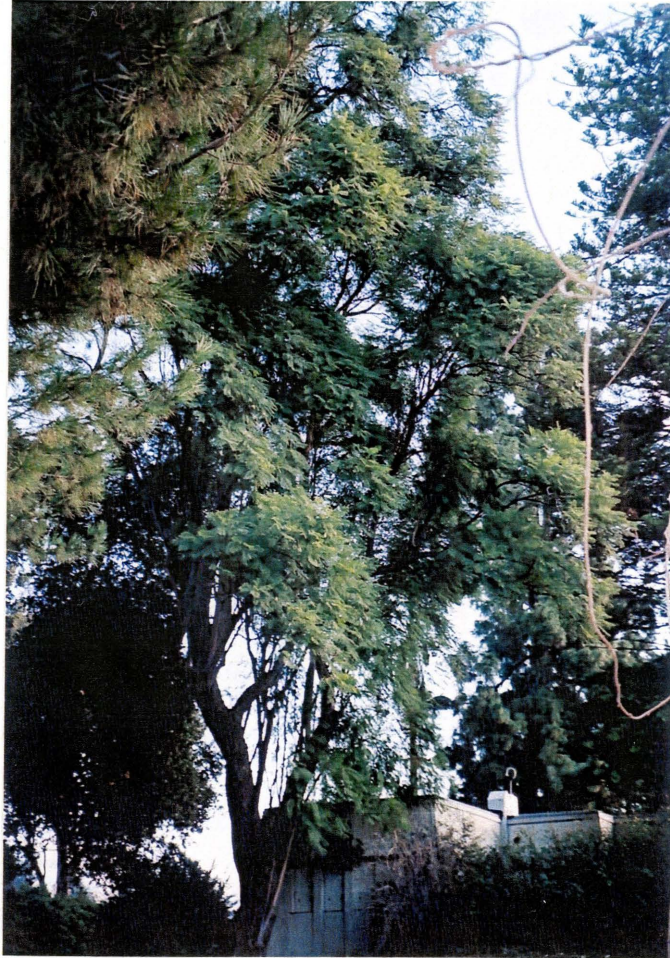
Jacaranda No. 26

Tree Number 26 is a Jacaranda specimen located just north of the Norfolk Island Pine. The foliage canopy spreads 48' extending into the Norfolk Island Pine and over the Adobe. A small myrtle bush adjacent to the tree trunk should be removed. The soil and debris covering the base of the trunk requires removal to expose the root flare and original grade. The tree would benefit from removing the trunk sucker growth and deadwood with pruning to shape the overall canopy.

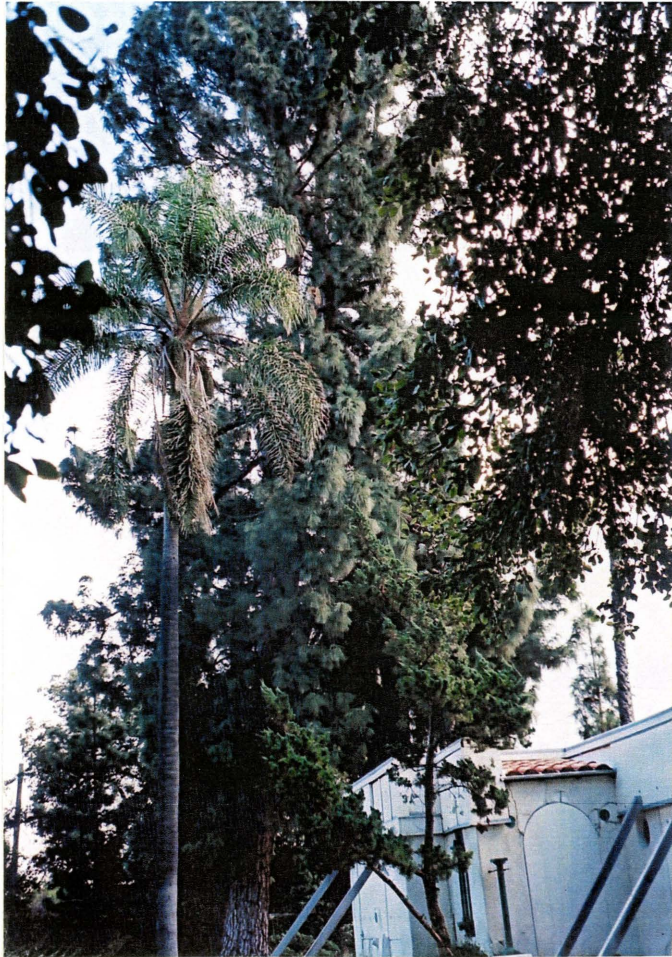
Tree Number 29 is a Queen Palm. The trunk diameter is 15" with a height and spread of 55' x 20'. The west side lacks foliage. The trunk evidences spike marks from previous climbing spurs. This tree is worthy of preservation where located. However, the tree can also be easily transplanted. No mitigations are required.

15A- Queen Palm No. 29  
(Canary Island Pine No. 30 in background)

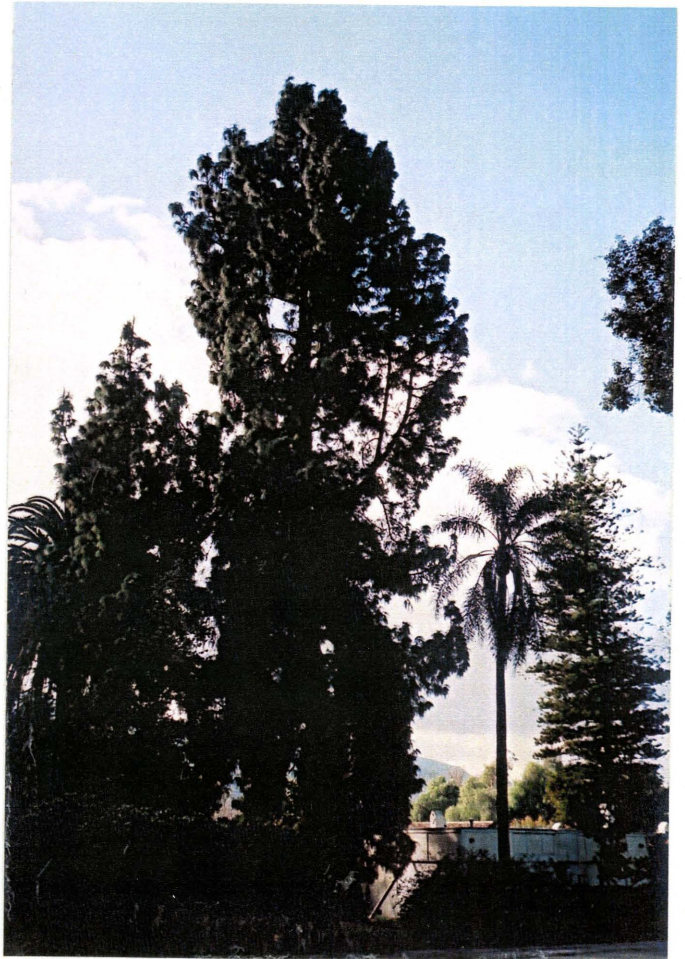
The largest tree in the study area is a 42" trunk diameter Canary Island Pine located to the northeast side of the Adobe. This is evaluated as tree number 30. The height and canopy spread are 90' x 40'. The tree leans slightly to the east, but appears to be stable. Minor deadwood and twig dieback were observed. This tree requires no mitigations at this time.

15B – Canary Island Pine No. 30  
(Queen Palm No. 29 on Right, Araucaria No. 25 in background)
