**National Register of Historic Places
Registration Form**

historic name St. Francis Dam (Site of)

other names/site number California State Landmark No. 919

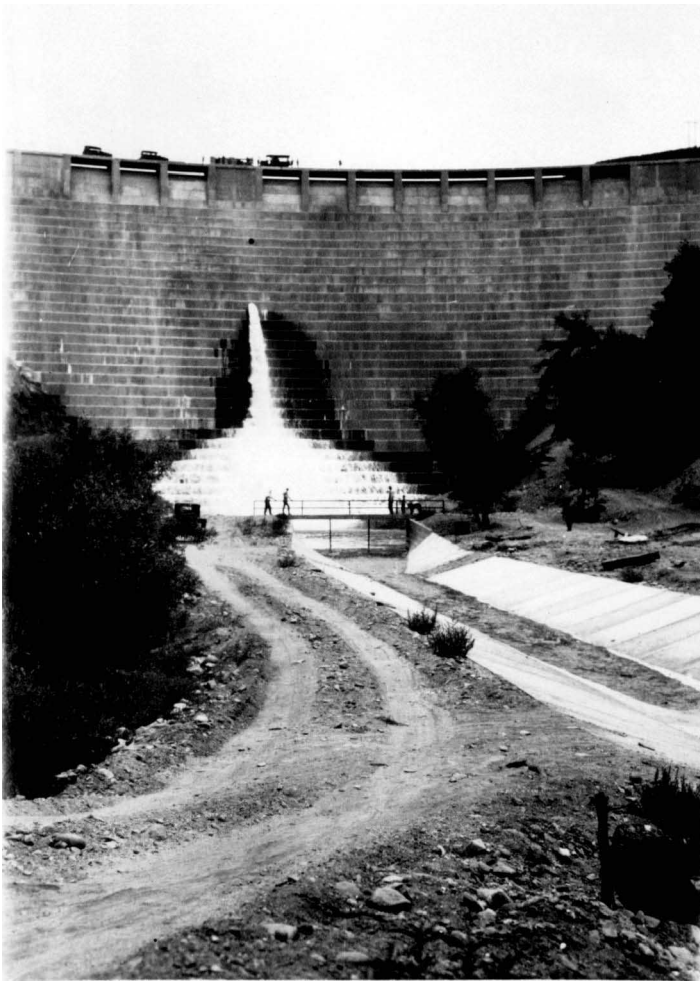
Figure 3. Downstream view of the face of the St. Francis Dam after its completion. The only day water was known to have been released from the reservoir into San Francisquito Creek after the construction of the dam began in 1924 was on the day it failed, but this photo was probably not taken on March 12, 1928. (Los Angeles Department of Water and Power)

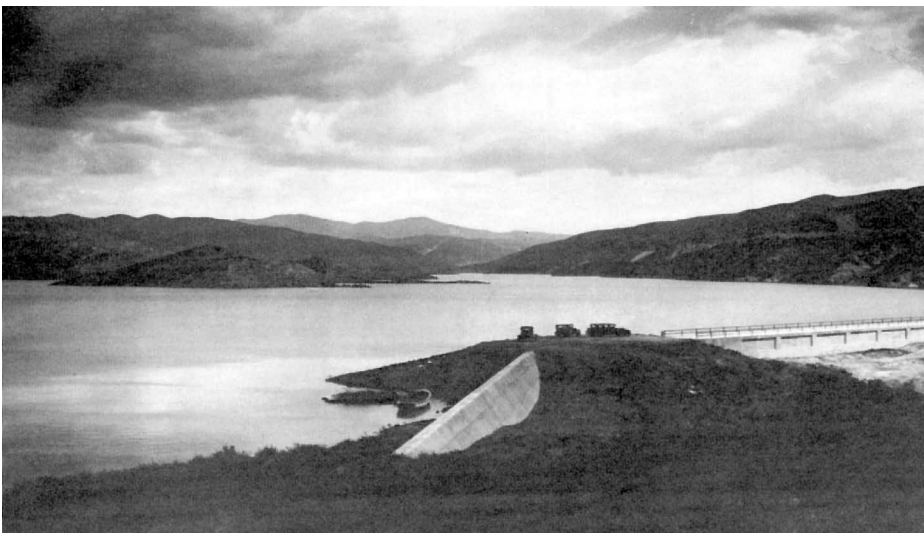
Figure 4. Portion of a panorama photo of the completed St. Francis Reservoir facing southeast, with the dam's western wing dike visible in the right middle ground. This photo was probably taken in early March 1928. (Los Angeles Department of Water and Power)

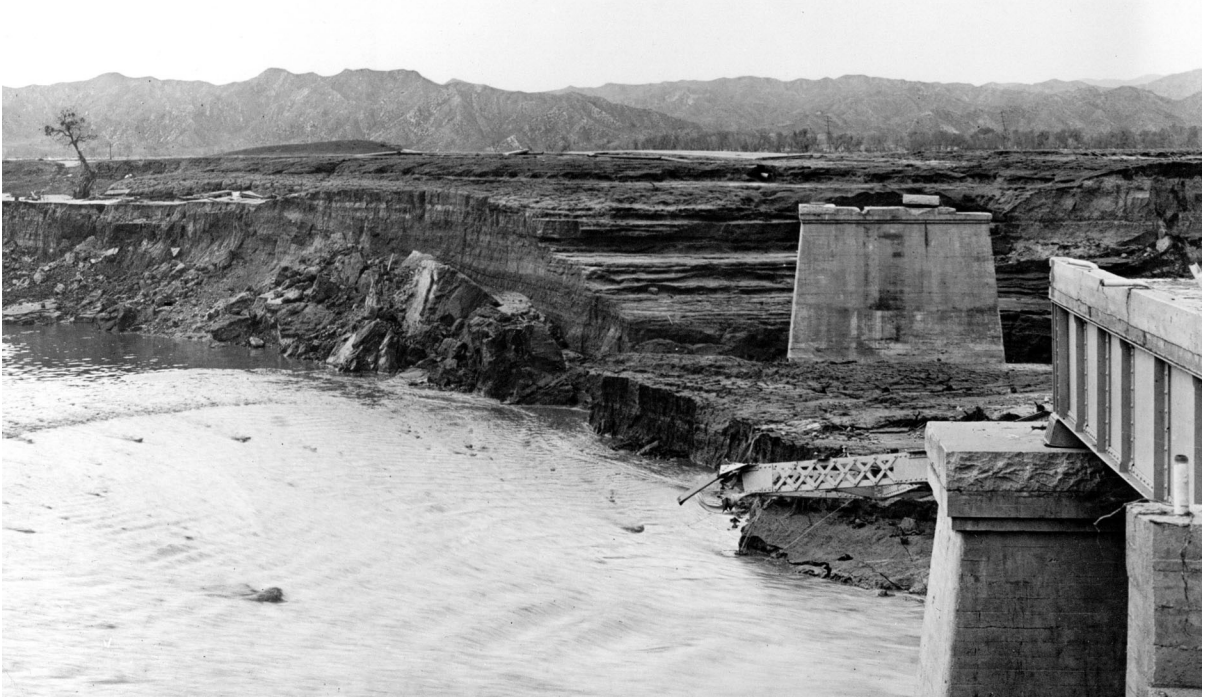
Figure 7. The remains of a highway bridge crossing the Santa Clara River near Castaic, probably photographed with a week after the dam's collapse. (John Nichols Collection)

As the deluge worked its way southwards through the farmsteads of lower San Francisquito Canyon, it suspended within its bulk a massive and destructive conglomeration of silt and debris, including rocks, trees, buildings and barbed wire. Less than an hour after the dam’s failure, the wave reached Castaic Junction, a hamlet adjacent to the Ridge Route over the Tehachapi Mountains. Several more lives were claimed at that location, and the main highway connecting Los Angeles and Bakersfield was buried under water, silt and debris. From Castaic, the main wave turned westwards, into the upper reaches of the Santa Clara River Valley. [Outland, 1963: 87-88] [Figure 7]

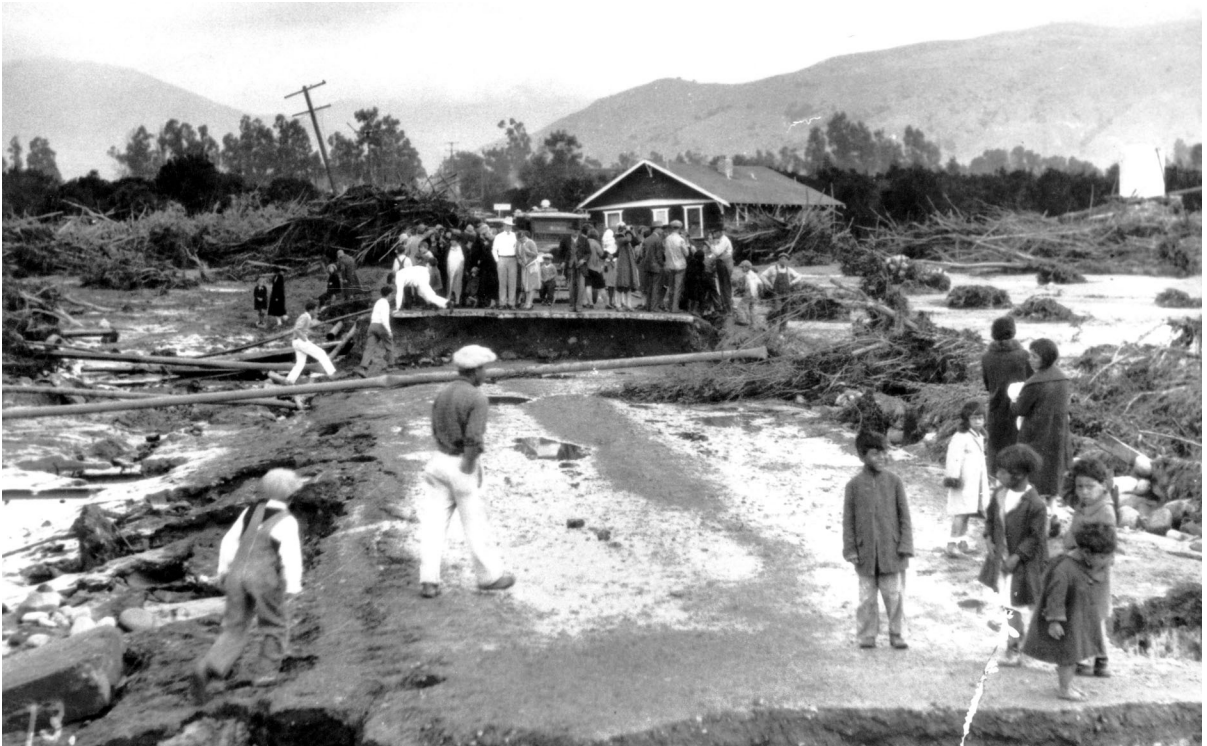
Figure 8. Santa Clara Valley residents inspecting a road washout on the northern approach to the Bardsdale Bridge, near Fillmore, probably on March 13, 1928. (John Nichols Collection)

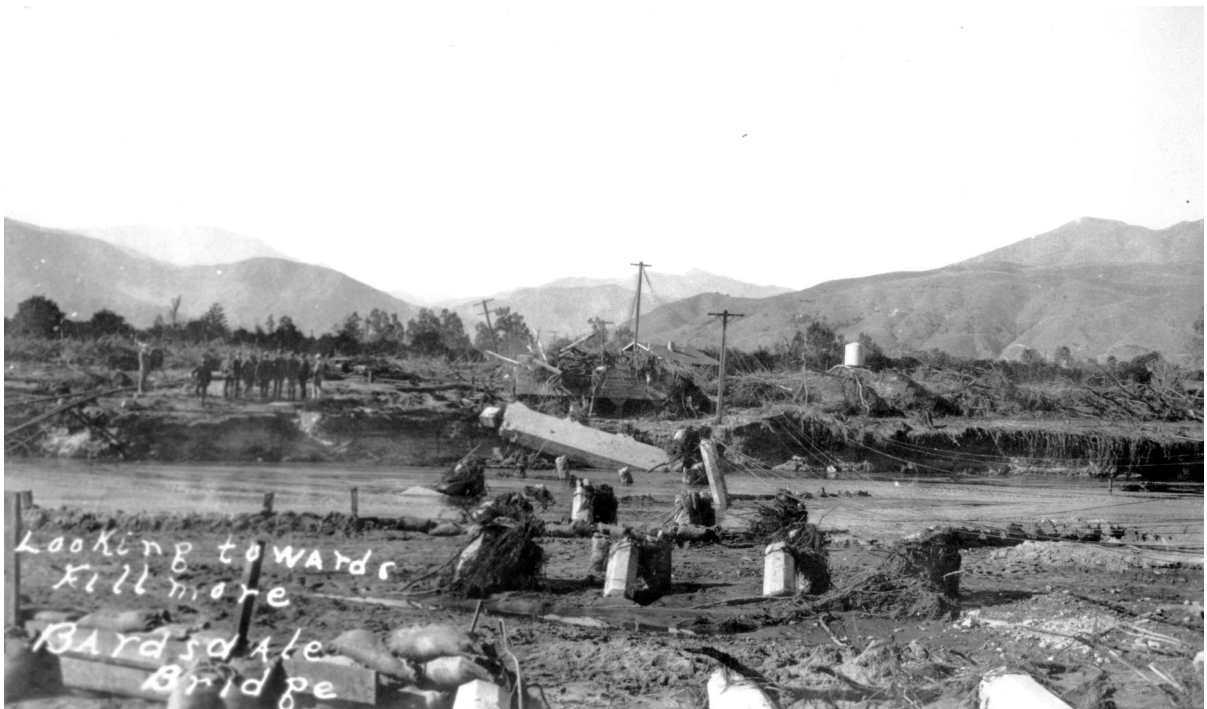
Figure 9. The remains of the Bardsdale Bridge, probably as photographed within a week of the dam's collapse. (John Nichols Collection)

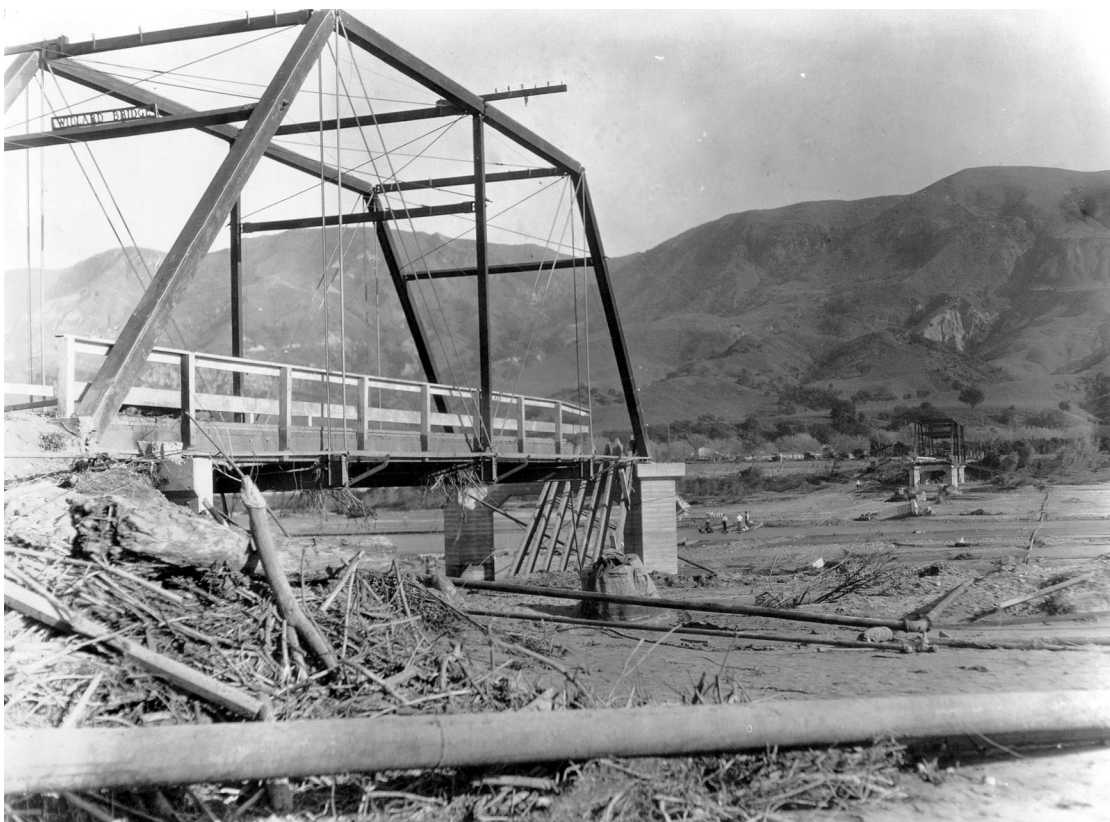
Figure 10. The Willard Bridge, east of Santa Paula, destroyed at 3:00 AM on March 13. Photograph probably taken within a week of the dam's collapse. (John Nichols Collection)

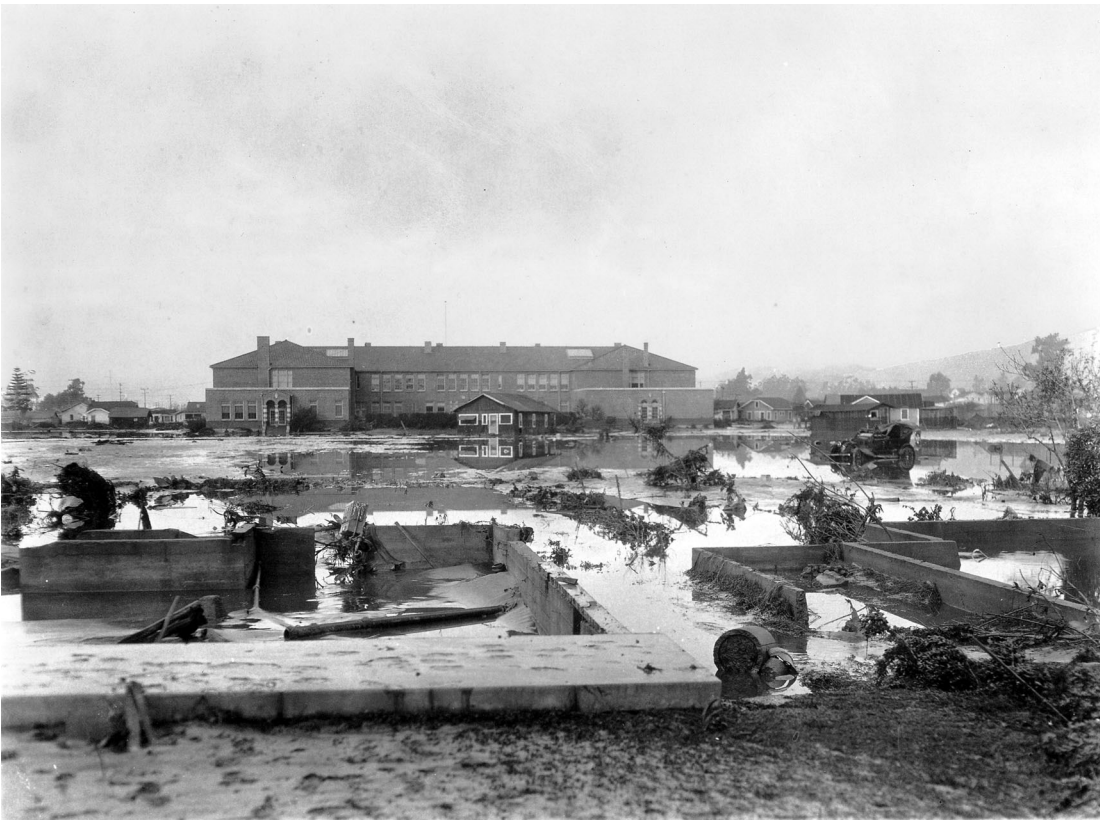
Figure 11. The Isbell Middle School in Santa Paula, and the foundations of the homes previously located on nearby streets, one of which is seen dislocated into the school yard. Photograph probably taken on March 13, 1928. (John Nichols Collection)

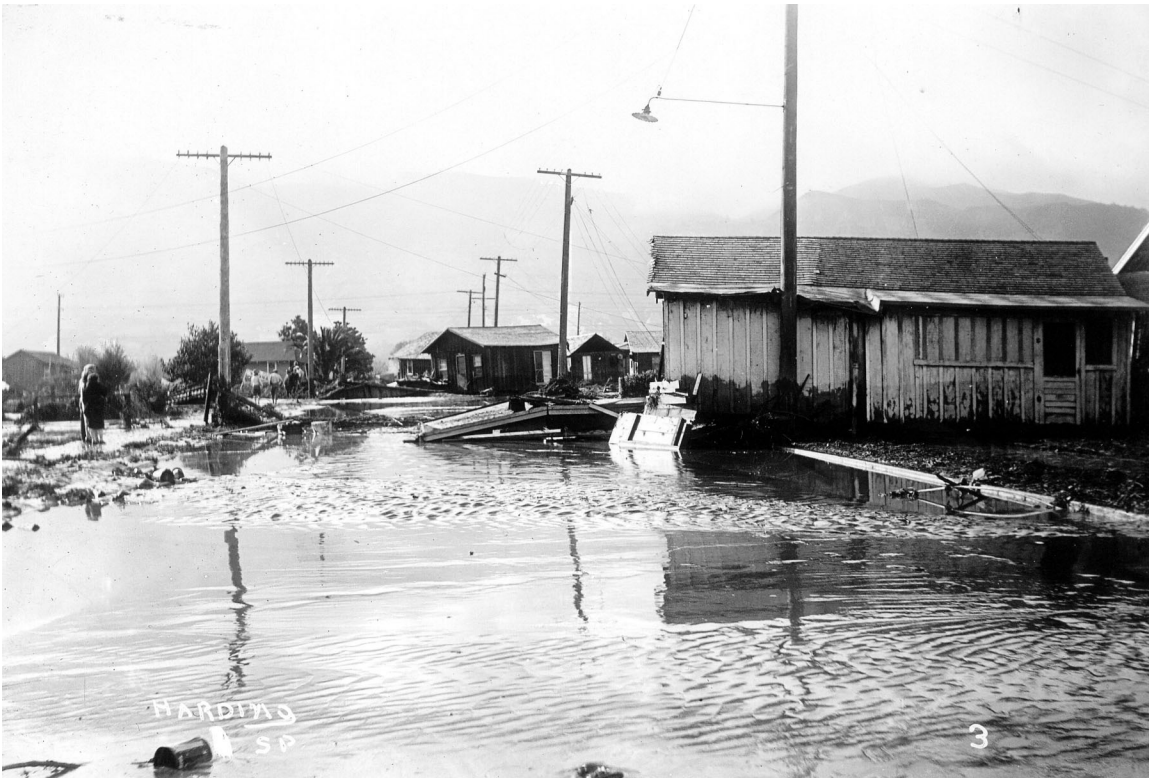
Figure 12. A destroyed residential area in Santa Paula. Photograph probably taken on March 13, 1928. (John Nichols Collection)

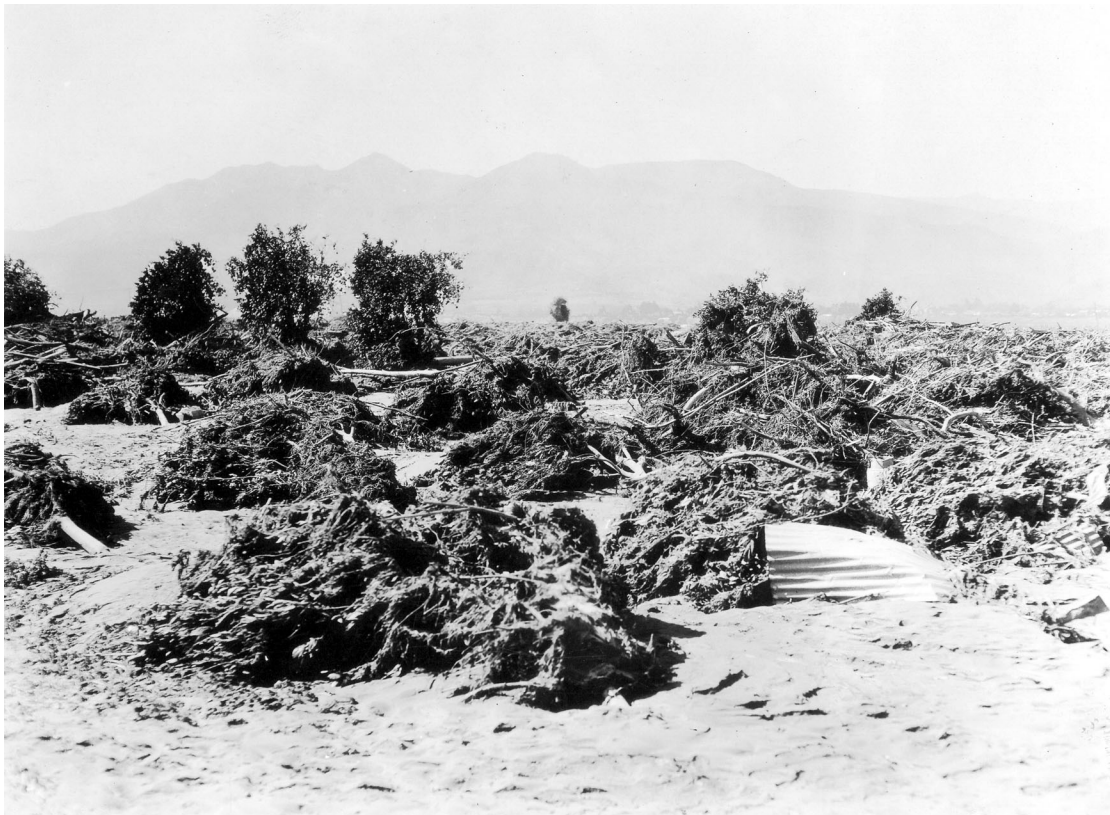
Figure 14. A destroyed citrus orchard, probably located near Bardsdale. Photograph probably taken within a week of the dam's collapse. (John Nichols Collection)

The best available estimates of property losses included eight miles of Southern Pacific Railroad right-of-way and four railroad bridges damaged or destroyed, nine-hundred nine buildings were destroyed and 331 were damaged. Over 23,000 acres of land, including nearly 8,000 in agriculture, were considered lost. [Figure 14]

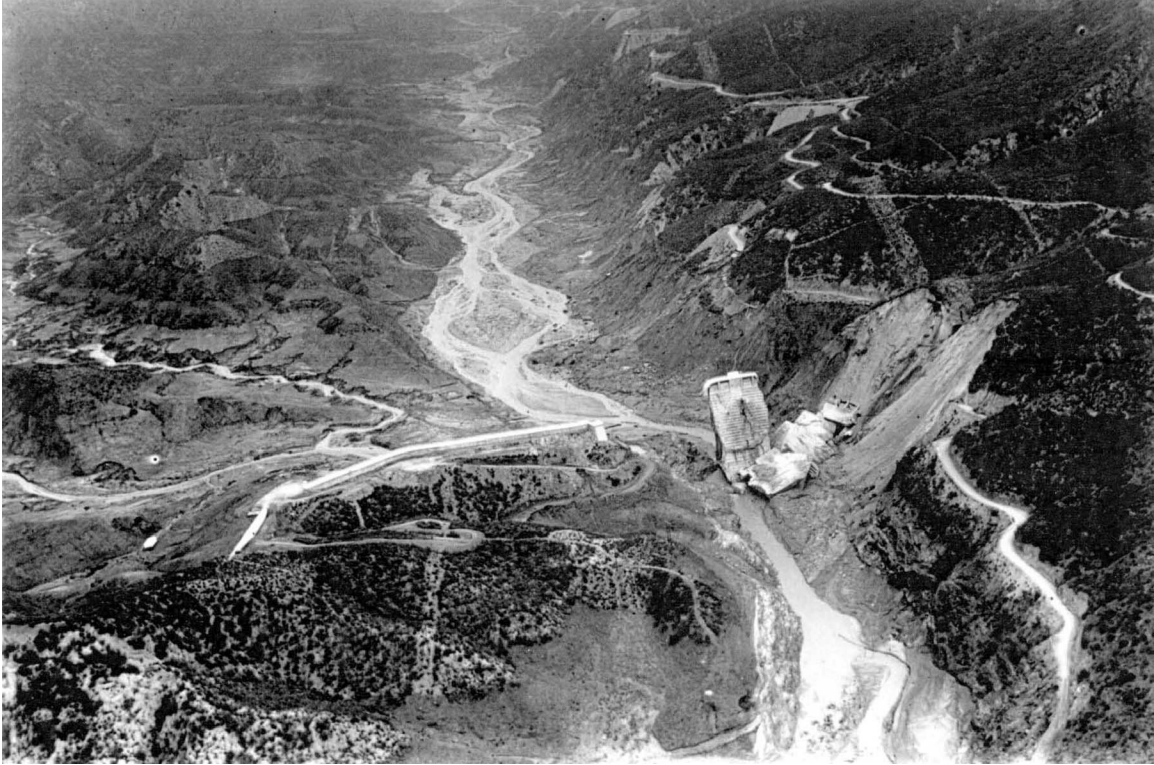
Figure 15. Aerial oblique upstream view toward the north/northeast at the dam site on March 13, 1928. Standing block No. 1 is visible in the center right middle ground, and the remaining sections of the wing dike on the dam's western abutment on the hillside to its left, as well as the massive landslide on the dam's eastern abutment. (Spence Collection, UCLA Dept. of Geography)

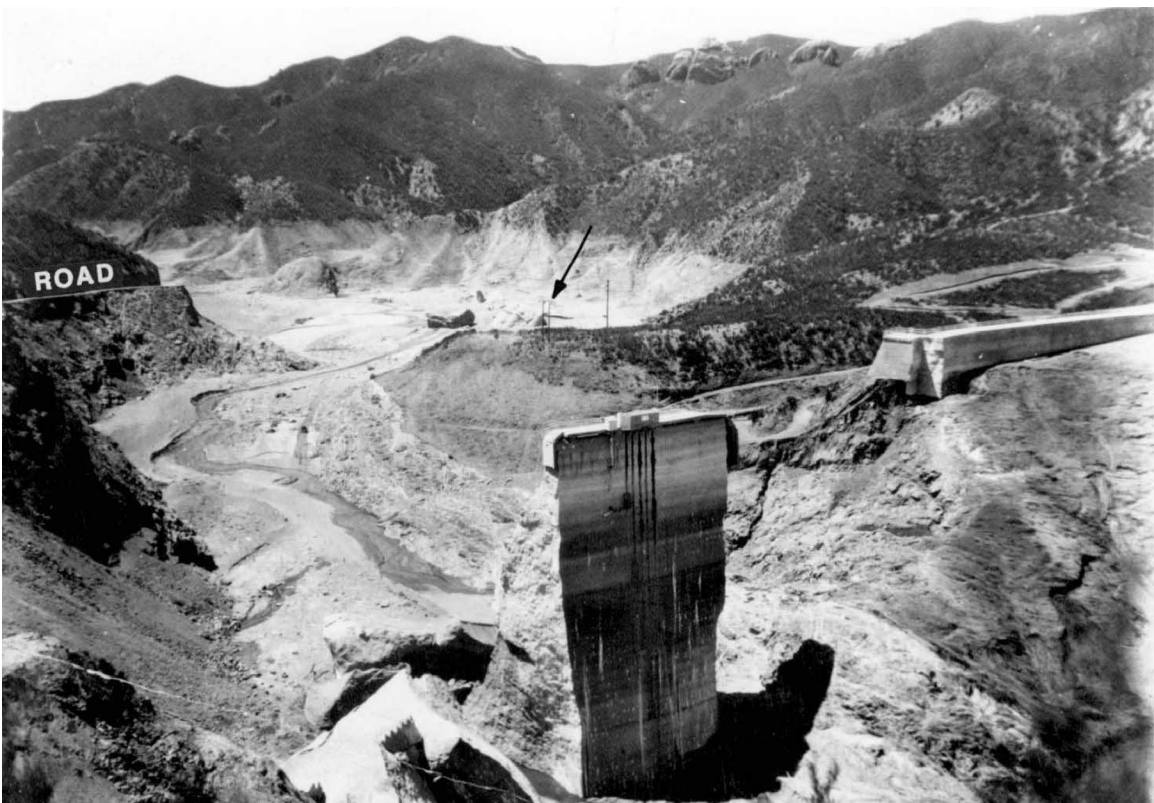
Figure 16. Downstream view after dam failure, showing standing block No. 1, a portion of the western wing dike, and scour line of the flood waters. Date unknown. (Ventura County Museum of History and Art, with notations by Rogers)
